INVESTIGATIONS IN THE VIEW GARDEN

Volunteer archaeology work in the
Kings Weston walled gardens

13th Jan 2024

Kings
Weston
Action
Group

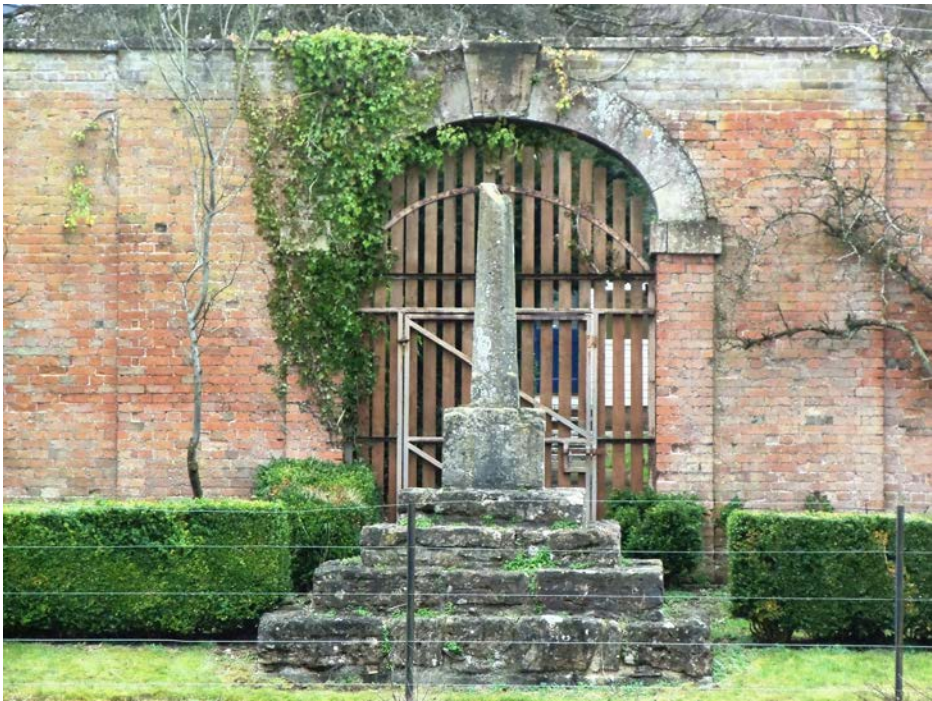
ABOVE: Bewy's Cross seen in its present location alongside the lilypond.

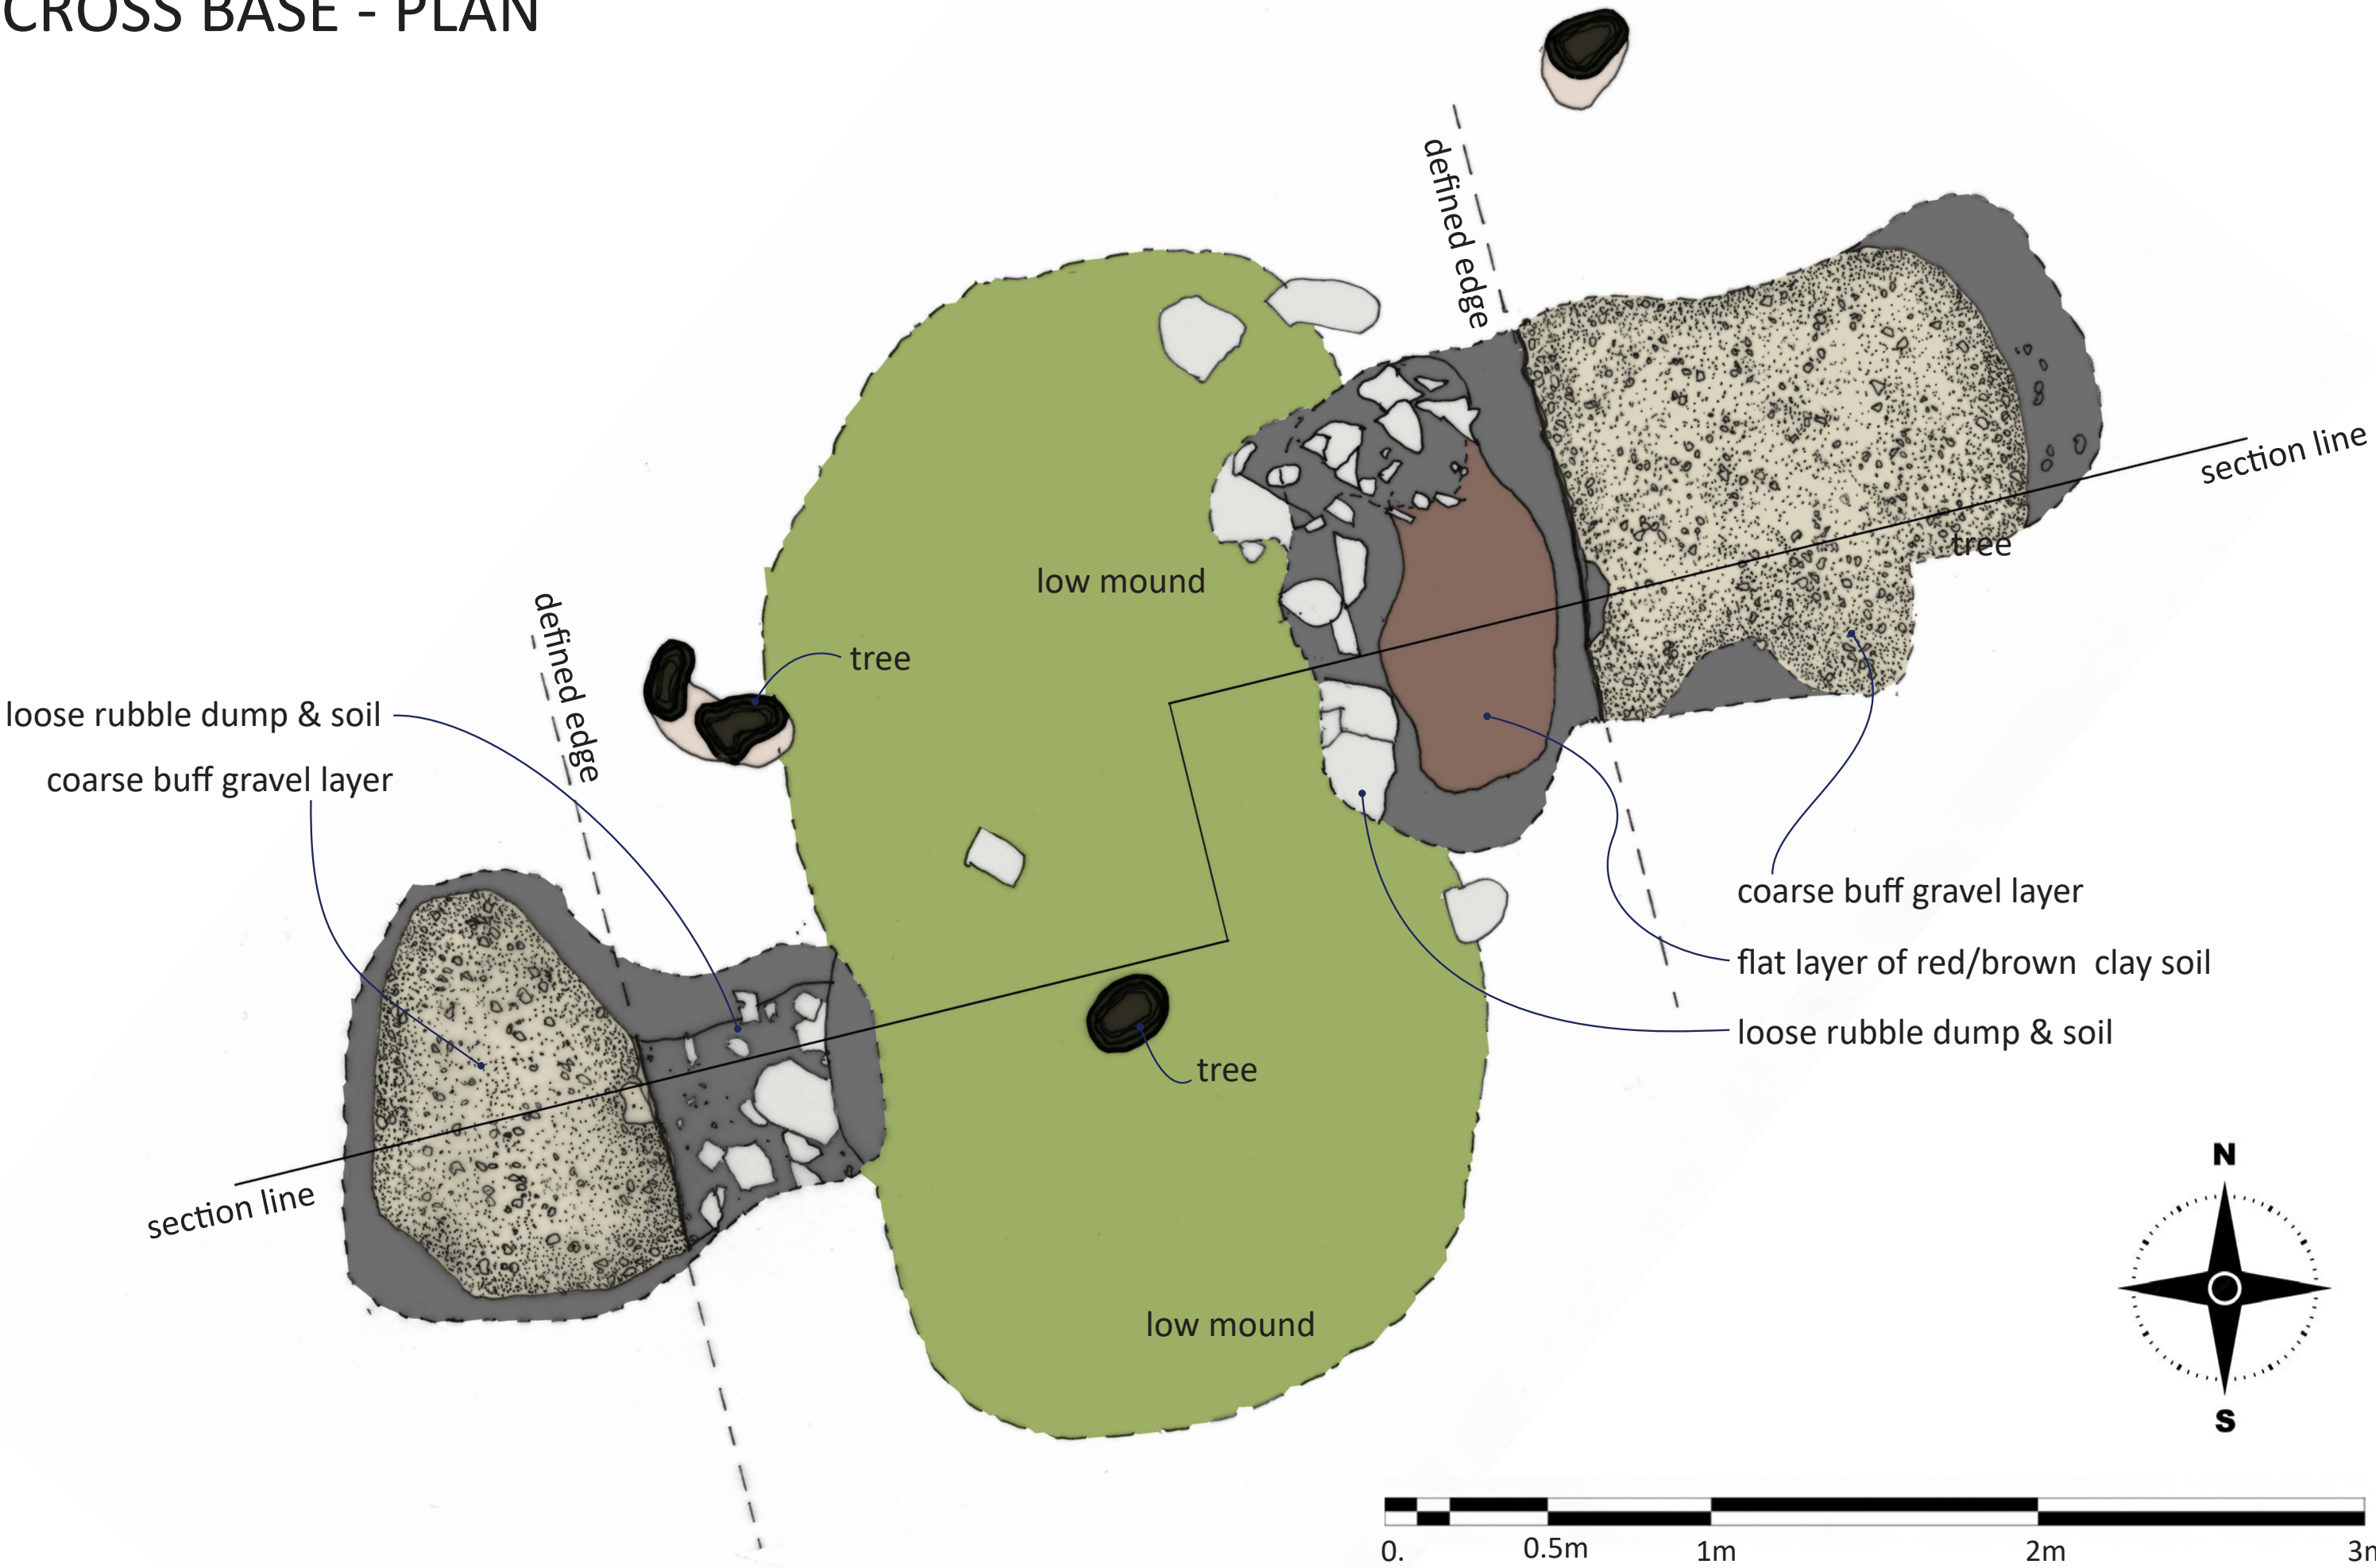
CROSS BASE - PLAN

Digging commenced at a convenient location measured 12m (40ft) from the lower set of steps on the axial east-east path through the View Garden, where the OS map suggested it had stood. This coincided with a low mound and a series of young self-seeded sycamore suggesting they'd taken advantage of disturbed ground to set roots. Efforts began on what would become the west side of this mound. Removing dark mulchy topsoil the dig quickly came down on a coarse buff coloured gravel surface just 6 inches (150mm) below the surface. Without further features, work moved to explore the east side of the low mound. Digging in this second location was confounded by a large amount of loose rubble stone of various sizes that formed the mound. The stones were local to the area, being variously limestone or Penpole stone. None showed obvious signs of working or of mortar that would otherwise suggest they came from a demolished structure. They were buried in the same dark loose mulchy soil encountered on the surface. This part of the dig was taken down further in an effort to find at what level the rubble finished, this bottoming-out at about 16 inches (400mm) in depth on a clear flat horizon of red/brown hard clay soil, presumed to be the natural.

A clear line separated the rubble-filled area to the west of this part of the dig, and the east side, where another buff gravel surface was encountered at a depth of 5 inches (about 125mm) below the surface. There was a clear edge

formed where the gravel finished before dropping about 11 inches to the red/ brown soil level. The gravel layer was extended eastwards, but no opposing edge was found, so this work abandoned.

Returning to the far west area of gravel that we'd first uncovered, this was extended eastwards to establish if a similar pronounced edge could be found; This proving to be the case, it was notable that it ran parallel to that opposing it in the eastern side of the mound. More loose rubble stone was encountered to the east of the gravel edge of similar character found elsewhere. Two stones were found in this material that retained traces of a very white mortar adhering to them but very little, and none in the surrounding dark earth.

We can be confident from the location and alignments that the gravel surfaces are likely to be the garden paths shown in 1884 that once ran around the cross before it was moved, and the space between them was where the cross was removed. The path surfaces survived in a well-preserved state beneath the topsoil, suggesting they were covered by debris before the cross was dismantled; this is supported by the condition shown in the 1950 photograph. The parallel edges to the gravel surfaces demark a central zone of 10ft 9 inches (3280mm) in width, within which a large amount of loose rubble appears to

have been tipped. From its looseness and general consistency, the dark soil mixed in with this rubble may have accumulated after it was dumped. This zone is slightly wider than the projected width of the lowermost step of Bewy's, however, it's postulated that, to dismantle the cross a trench was required to be dug around the base to lift and remove the stones. This would seem necessary judging by the depth the lower step shown to be buried in 1950 compared with its current profile at the lilypond. A trench cut around the base would account for any additional width found in our dig.

Following the dismantling and removal of the cross to its new location at the lilypond in 1951, the hole left appears to have been filled with rubble stone. This stone had no evidence of having be part of the historic cross, or having come from another built structure, and was probably used simply to make the site safe and level.

The red/brown clay layer at the base of the trench is considered the natural subsoil. The clear differentiation between this and the rubble stone dumped on top of it suggest either any foundation to the cross was robbed out when it was moved, or it had no foundation and sat directly on this layer. Taking the dig further to the west, removing more of the rubble area, may have uncovered more evidence, but tree roots prevented easy investigation. Establishing the southern edge of the cross base and path would help to better pinpoint the feature within the garden.

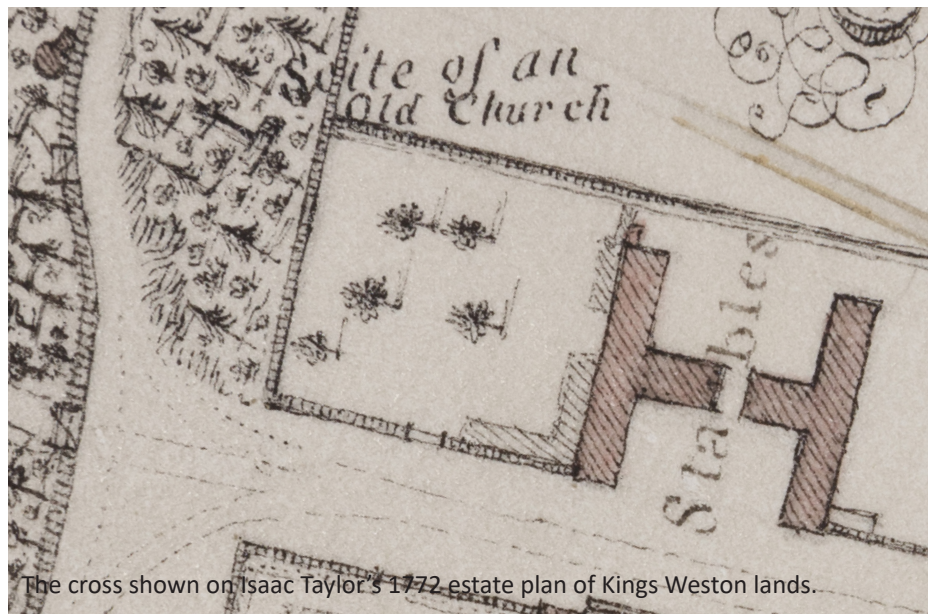
The cross shown on Isaac Taylor's 1772 estate plan of Kings Weston lands.

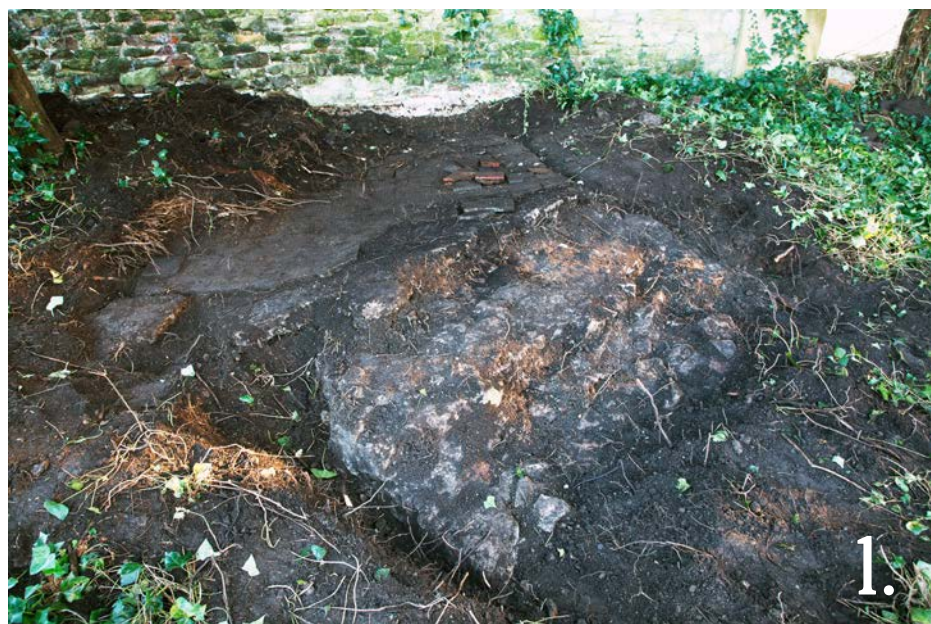
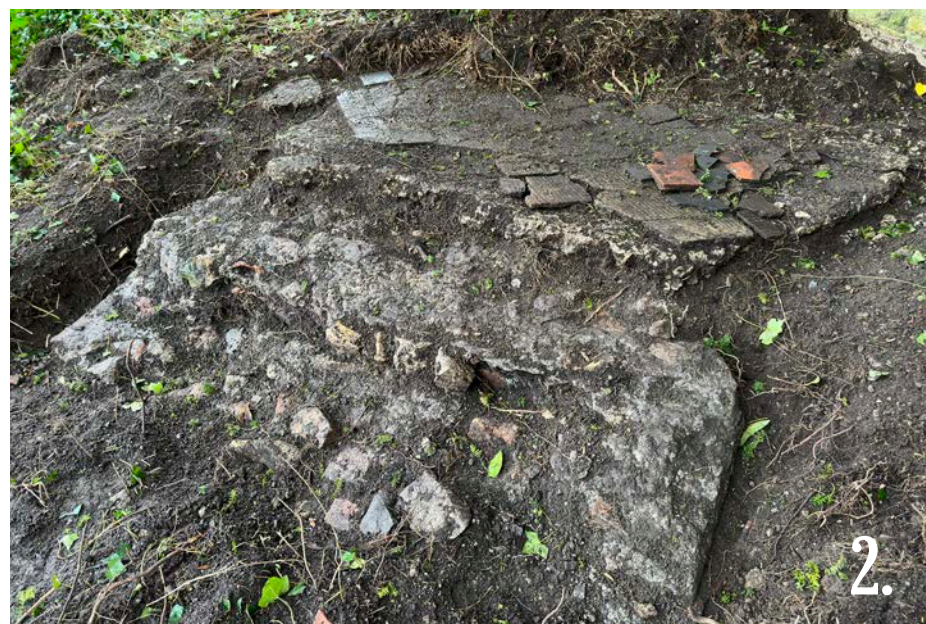
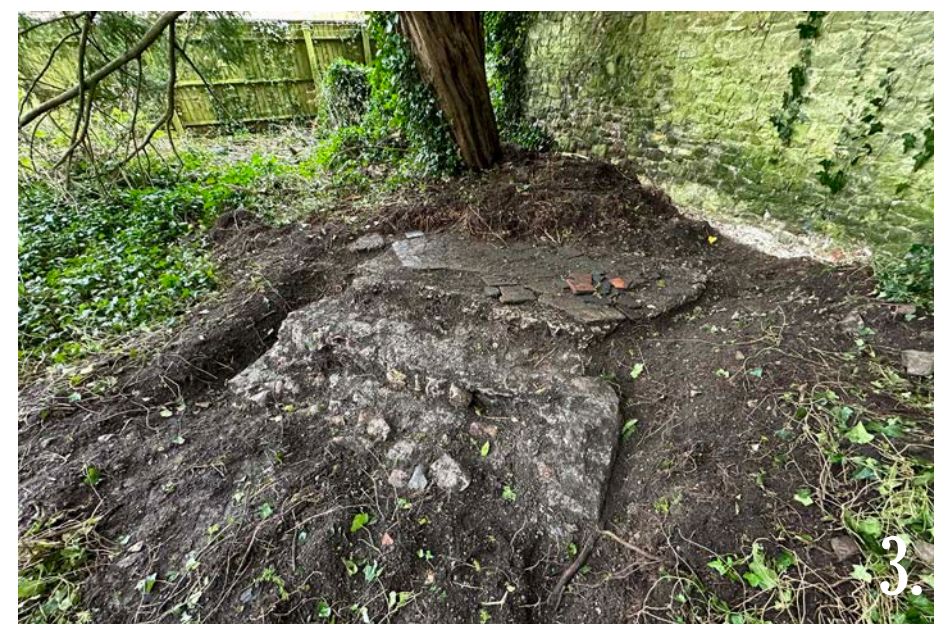
- 1: the freshly excavated remains looking south towards the Georgian wall surrounding the View Garden
- 2: detail of the excavated remains showing the stepped front feature and slumped floor surface behind
- 3: the remains of the garden building seen in context with the georgian wall on the right and yew tree behind.

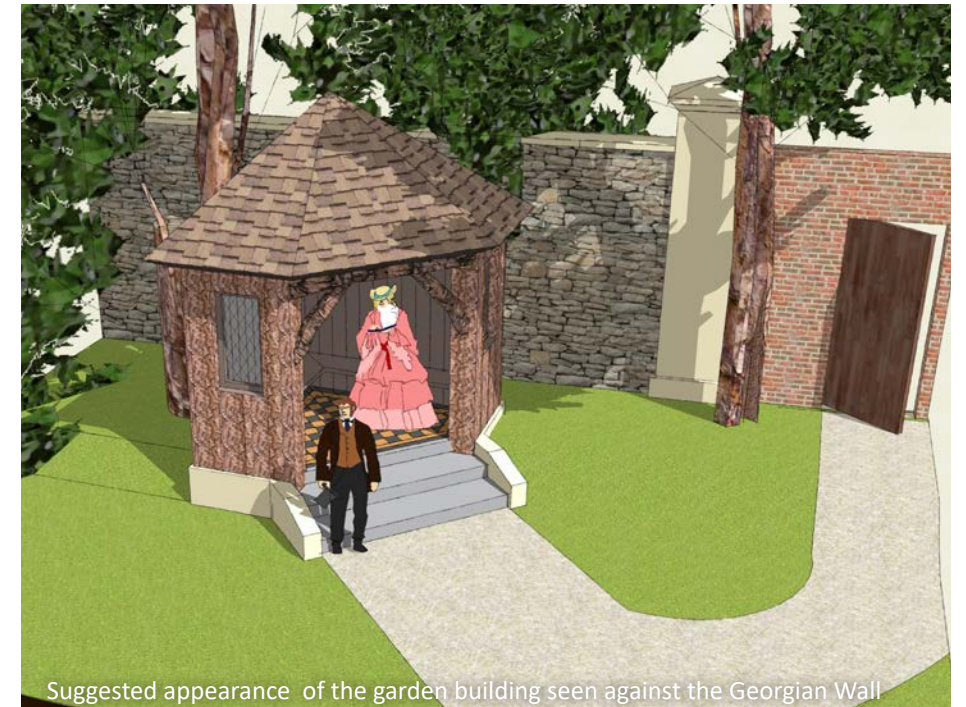
Suggested appearance of the garden building seen against the Georgian Wall

The other possibility is that the building was fabricated from timber and other organic materials; these would require a less substantial foundation and decay to nothing over time. Many garden buildings of the 18th and 19th Century were built in this way, with some making deliberate use of the rustic character of natural logs, boughs, bark, and thatch for picturesque effect. The slumping of the floor and disintegration of the edges could have begun early in the building's history, without the support that more durable structures could have provided.

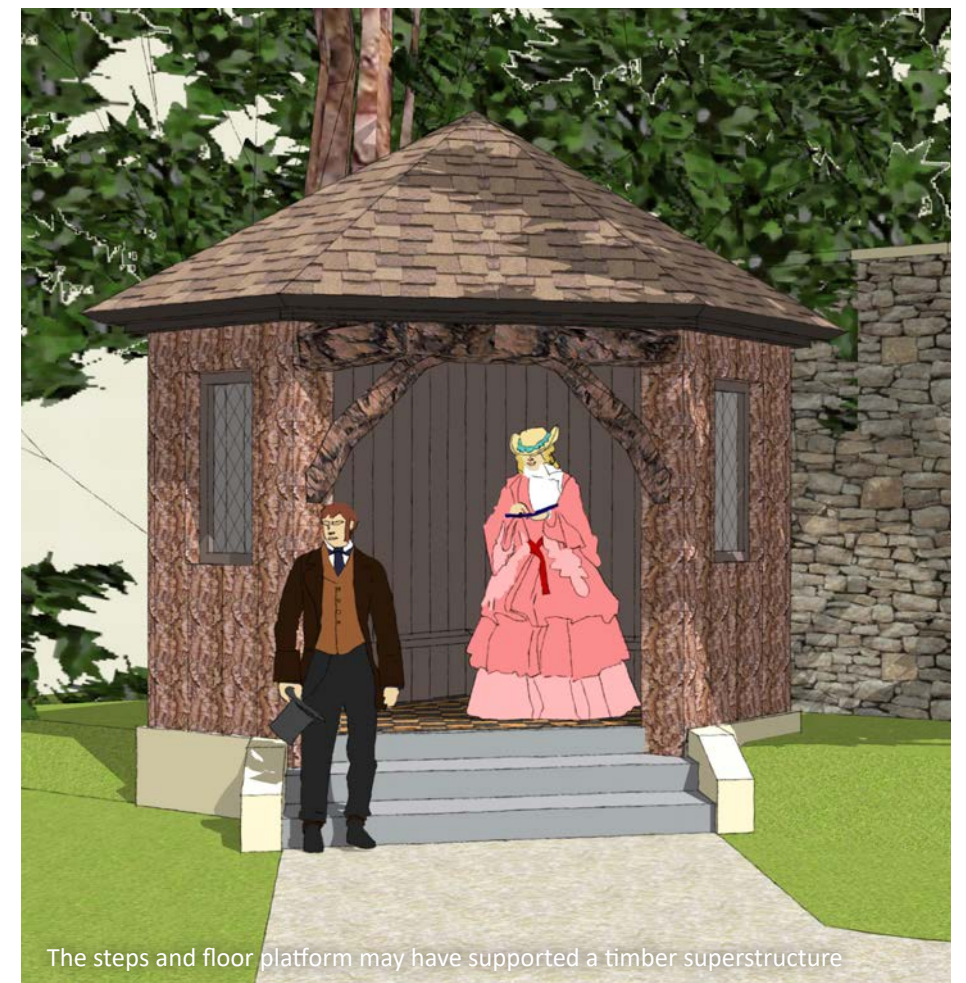
The steps and floor platform may have supported a timber superstructure

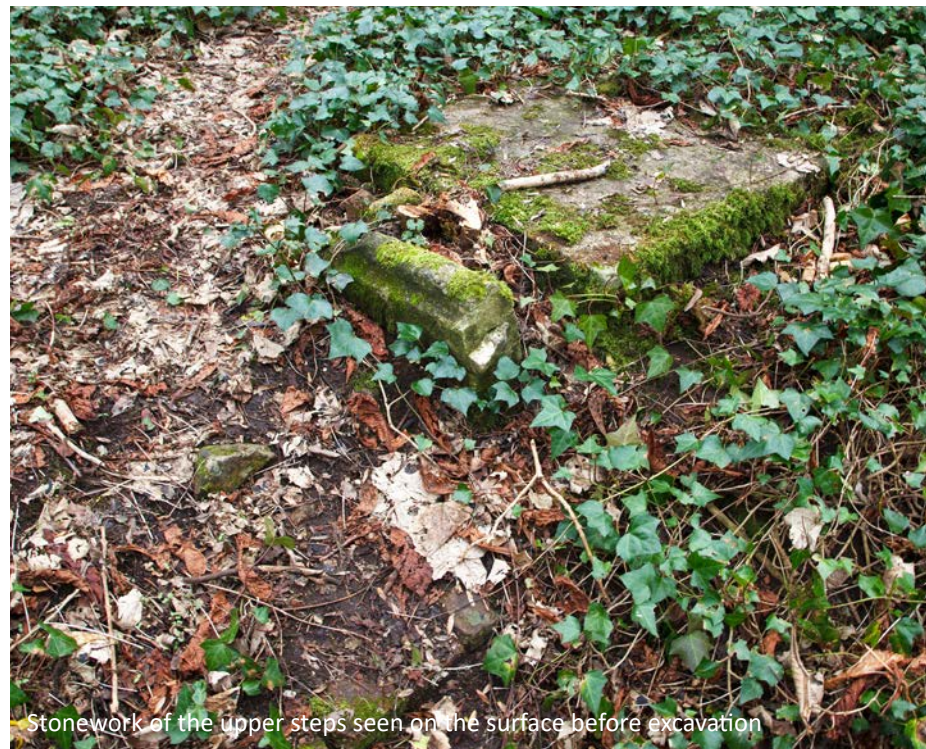
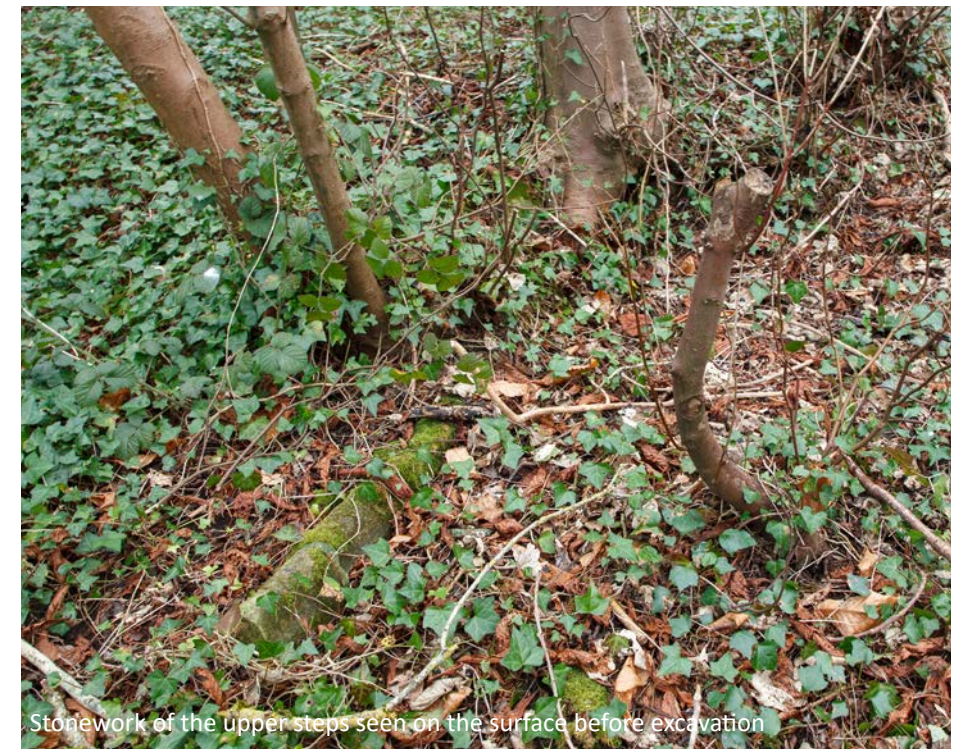
Stonework of the upper steps seen on the surface before excavation

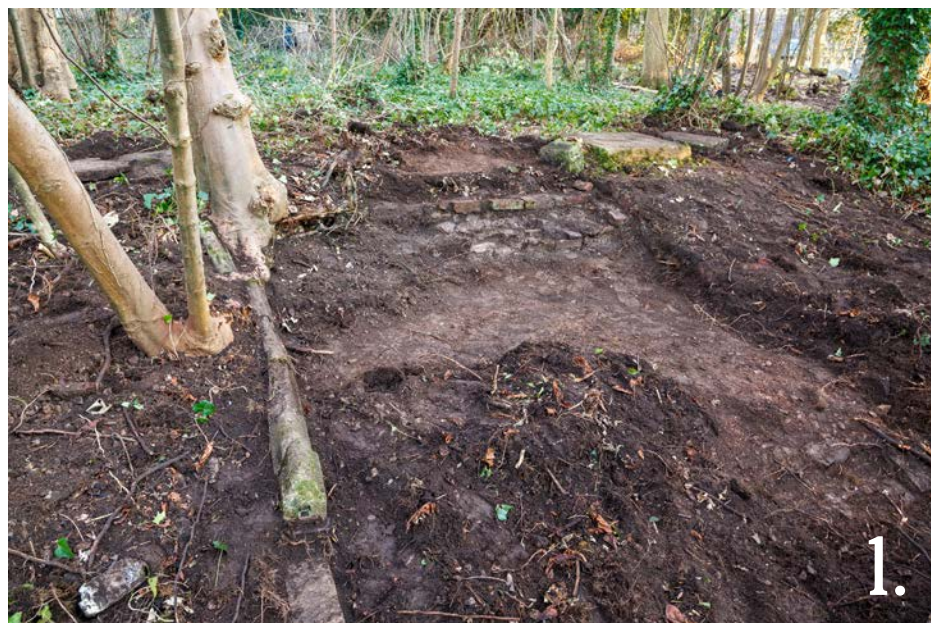
1. The upper steps from the west. The decorative stone edging remains largely complete on the left. Upper and lower gravel surfaces can be seen separated by the steps foundations.

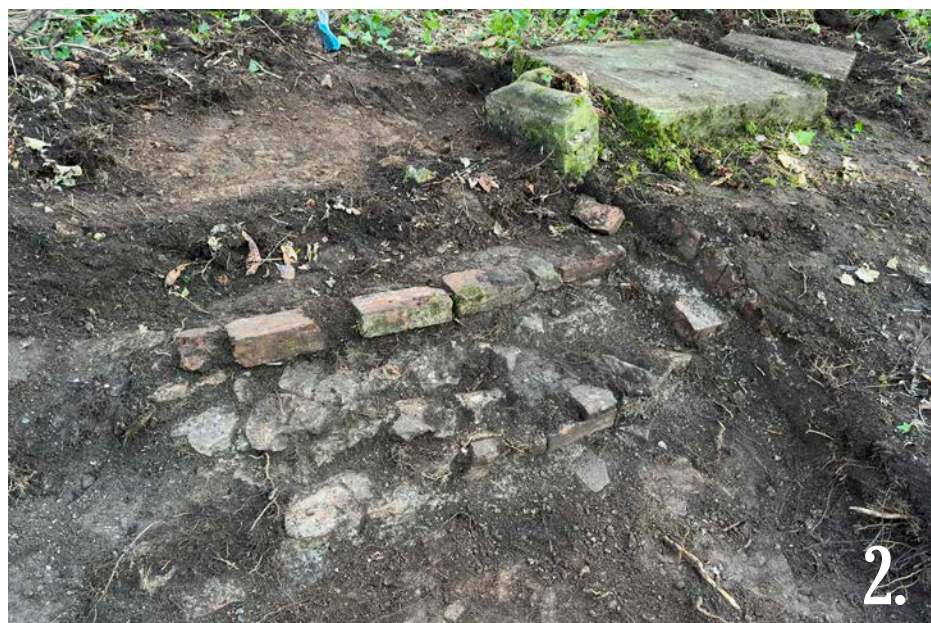
2. Detail of the steps foundation showing the step platforms edged in masonry and brick. A sharp line demarks the forward edge of the upper gravel surface. The ashlar limestone blocks are clearly visible, with the corner of the decorative edging seen in-situ against the larger one.

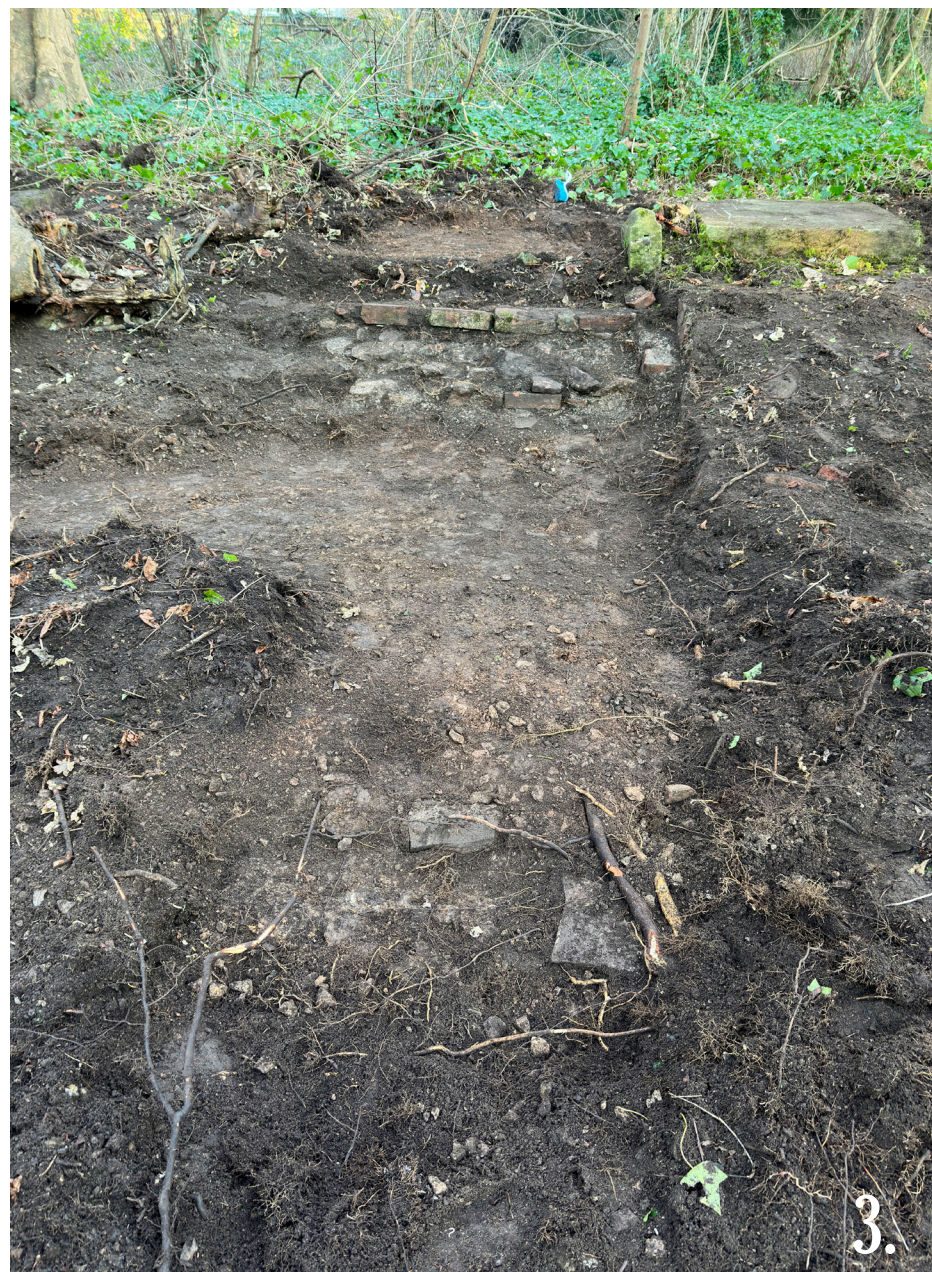
3. A view directly east up the axial path. The foundation of the single last step is seen in the foreground, fronted by unexcavated dark soil, with the gravel surface beyond it. This view graphically demonstrates the difference in height between upper and lower gravel surfaces.

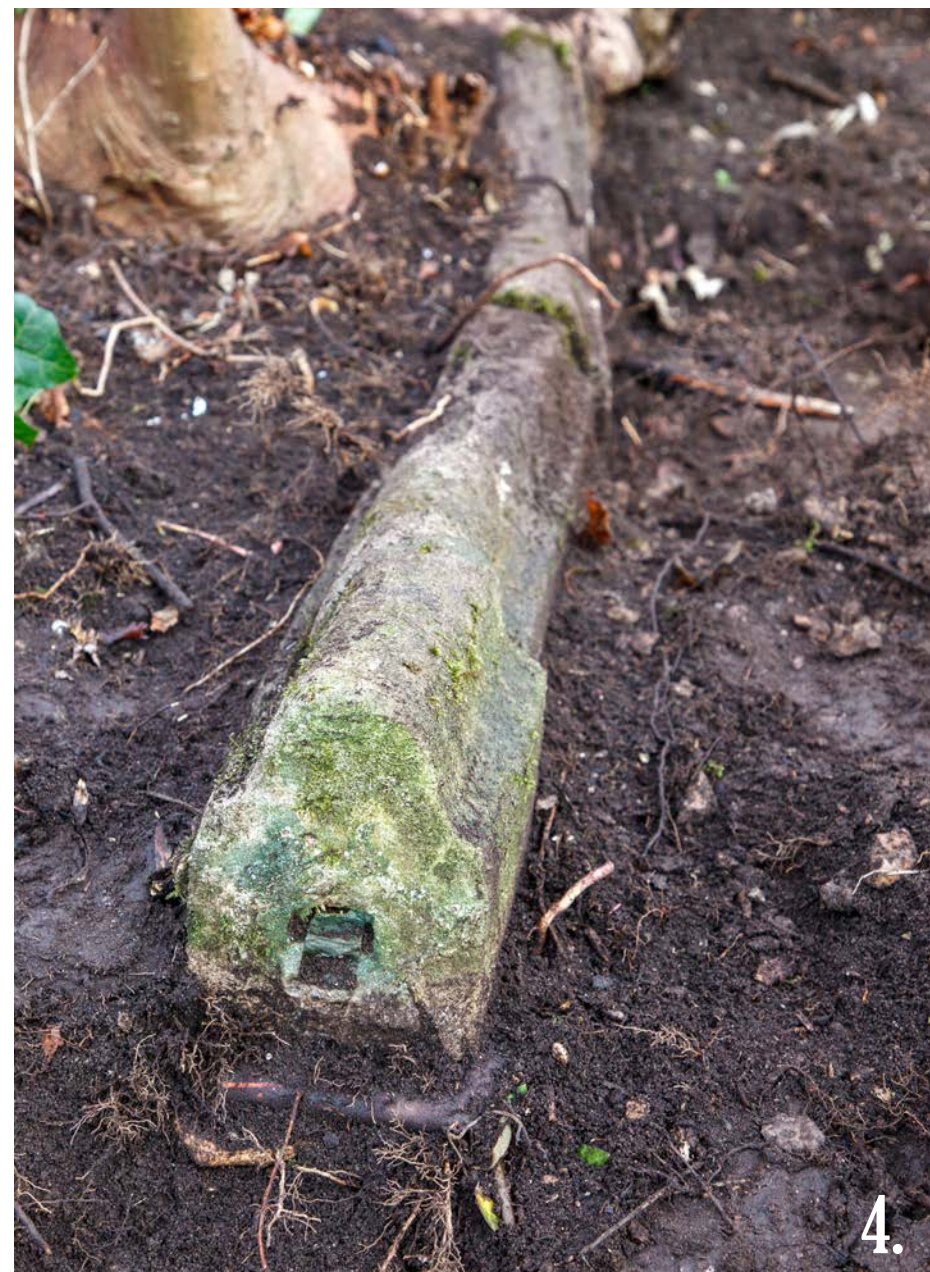
4. Detail of the end of the decorative edging along the north side of the steps, showing the curving profile and socket for the connecting plug into the next block.

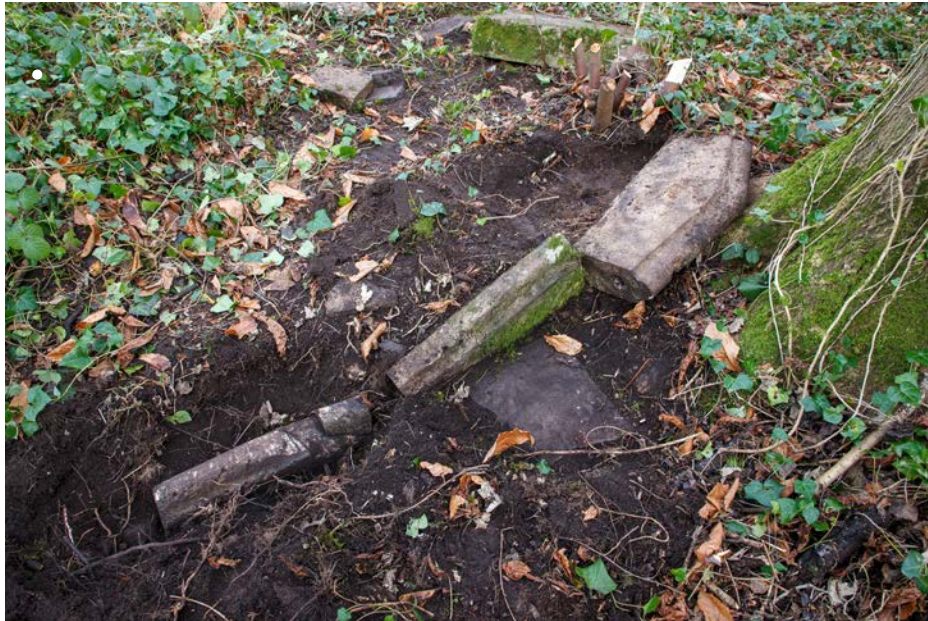
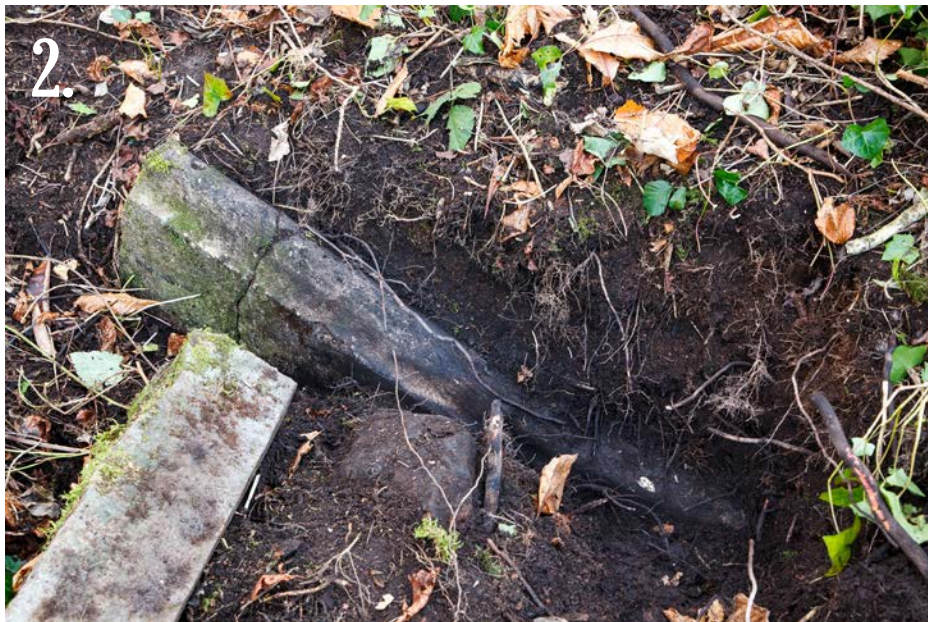
1. The remaining stone edging on the northern side of the lower steps. A fragment of the step itself lies in-situ
2. The edging on the south of the steps showing the graceful curve where it levels out at the bottom. The largest section of remaining step lies upright on the left.
3. A reconstruction of the steps to their original scale and appearance.

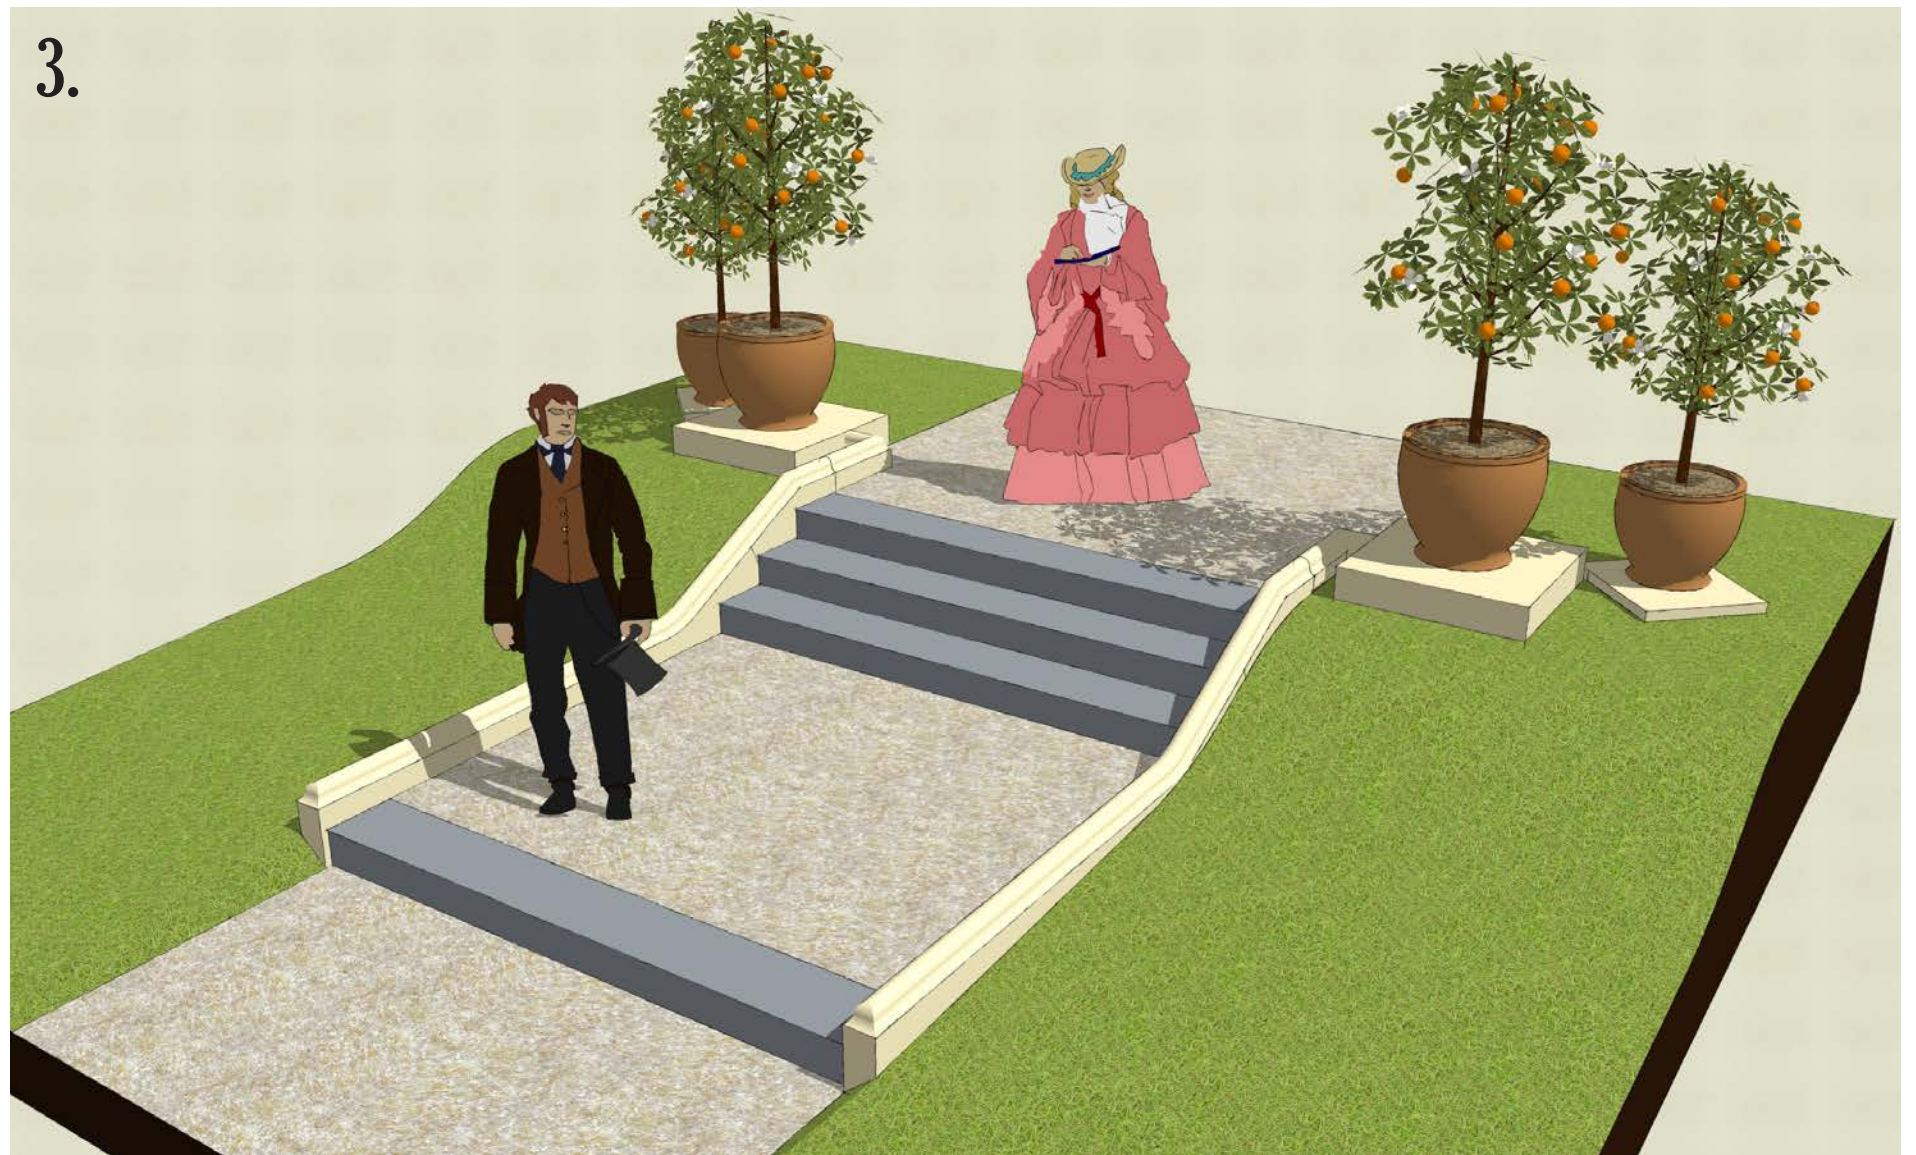
The decorative stone edging also appears to have succumbed to salvage. Only the sections with odd angles or with clear damage survive, whilst any regular

long sections look to have been taken. One section of edging lies on the surface of the upper set of steps, removed from its location, but broken, perhaps damaged during removal and discarded. The termination of the decorative edging against the upper stone blocks suggests it was localised to the steps and didn't continue the length of the axial path. Where their ends were exposed square socket holes had been cut to receive square plugs of slate, used to align and fix the stones together and set in place using mortar.

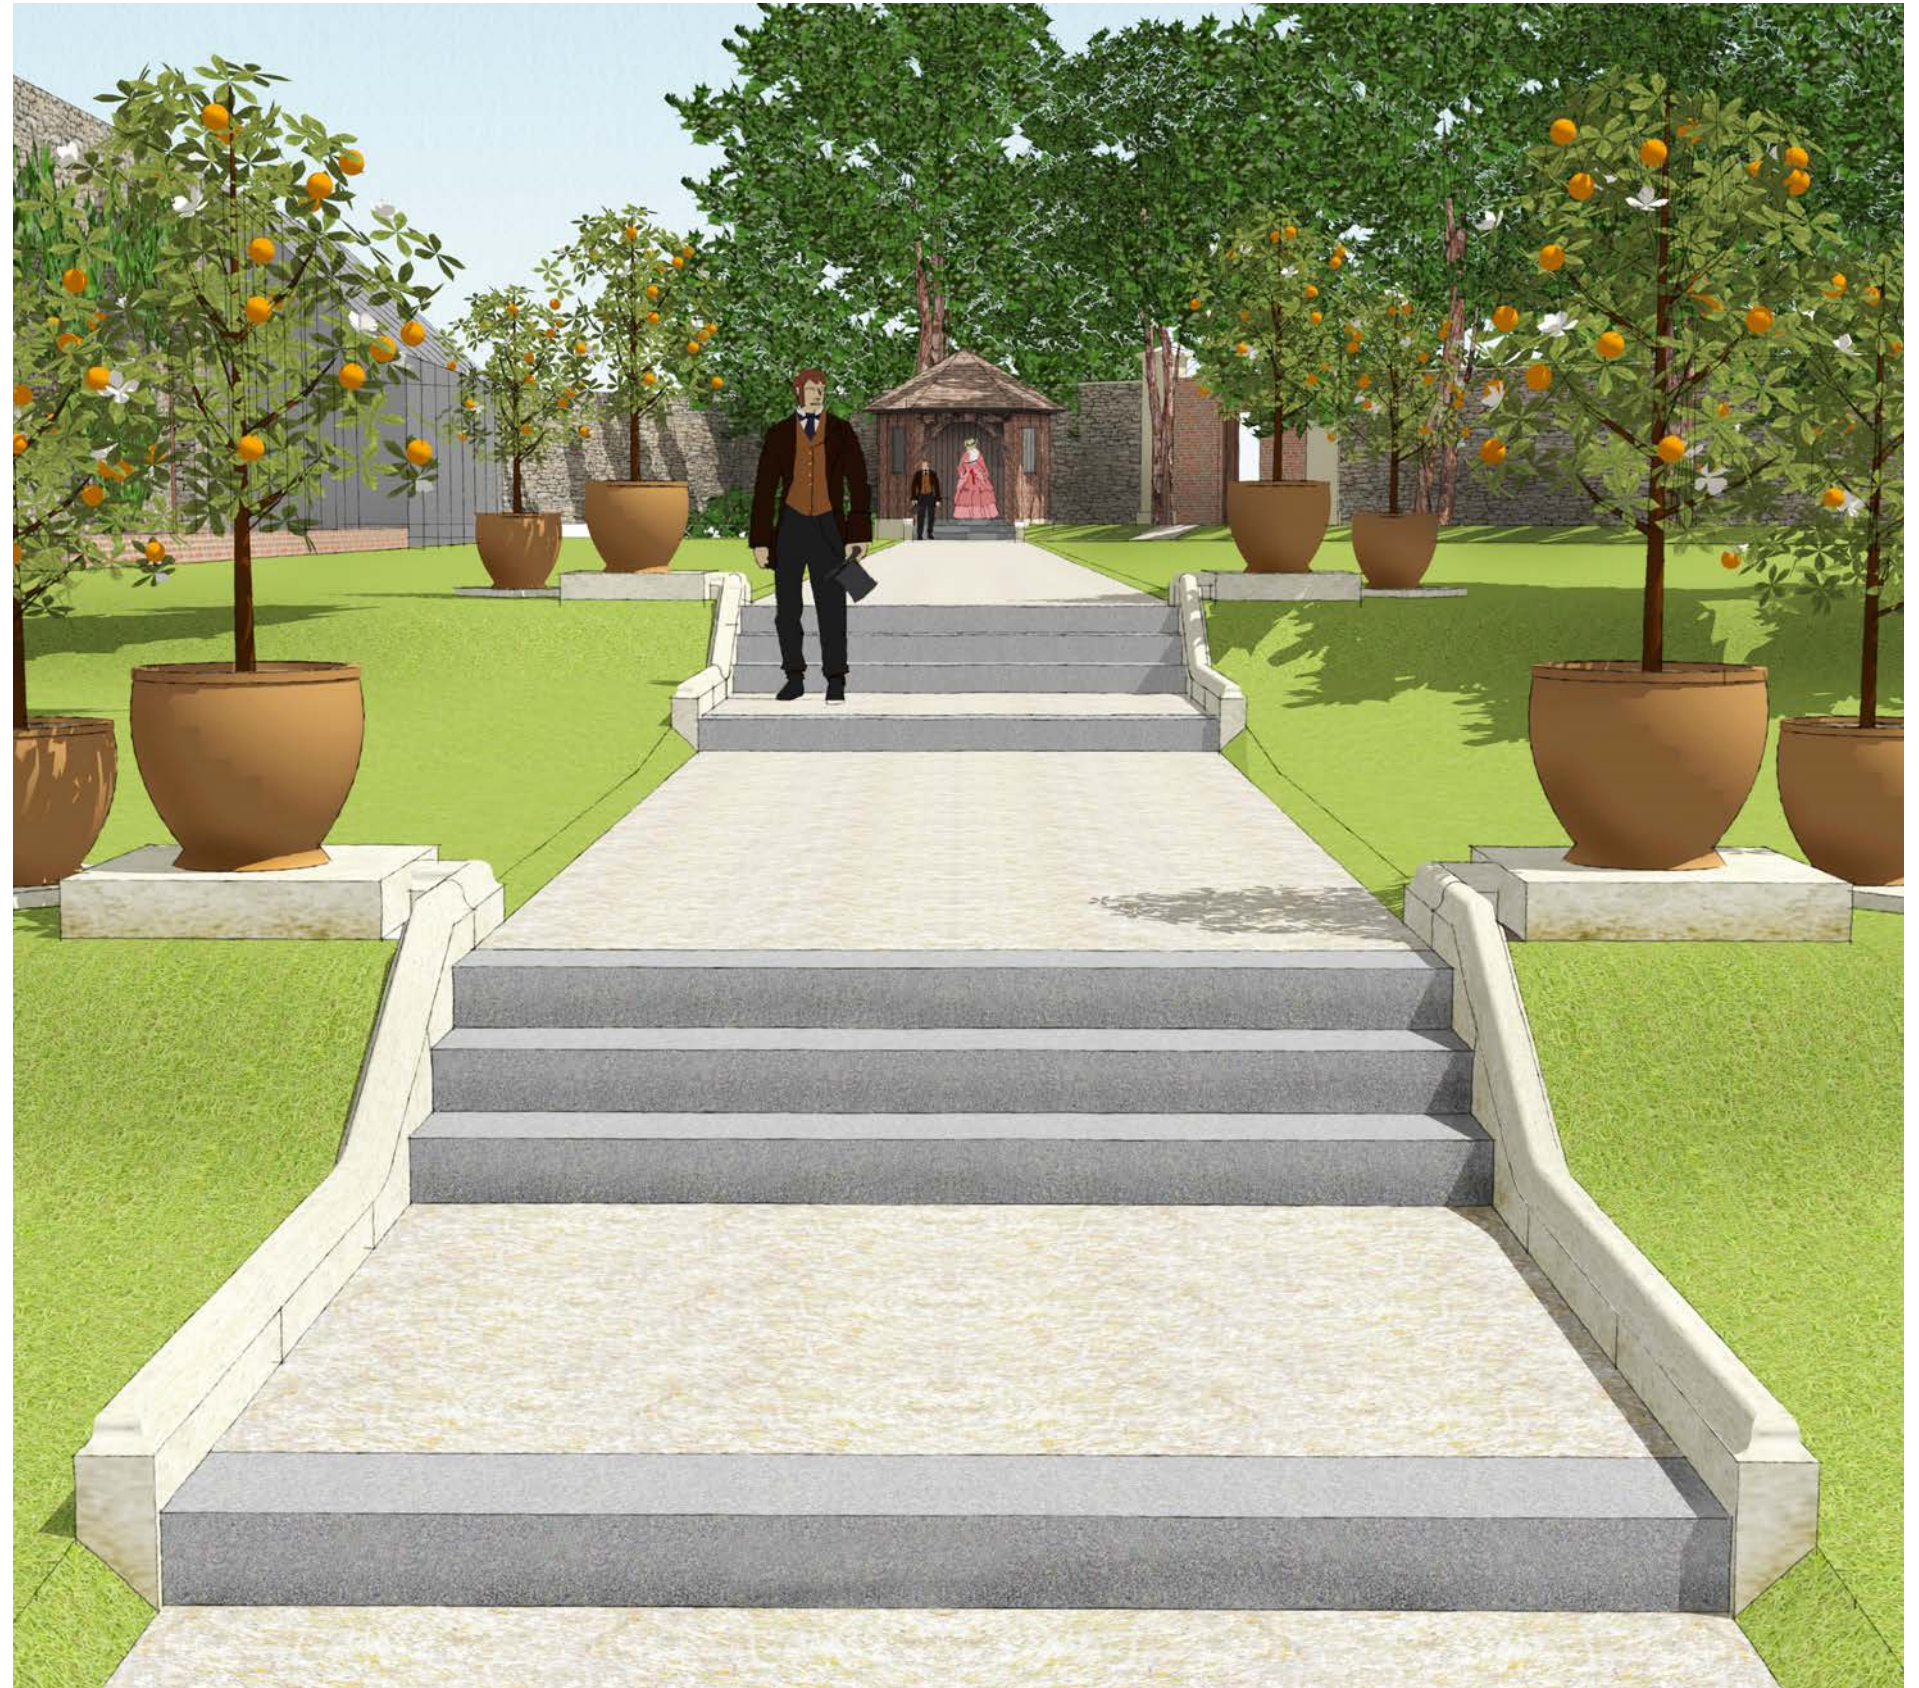
RIGHT: A reconstruction of how the view along the axial path towards the garden seat might have looked.

The function of the limestone blocks and their satellite slabs is our final consideration. As found, with a smooth and level top surface, there were no indications that any of these blocks ever had any structure built upon them; Nor were any of the blocks of adequate depth to support anything of any scale or weight. Had they been the bases for garden urns or statues a degree of differential weathering would have been expected, highlighting the outline of any permanent feature stood upon them. The proximity of the Georgian glasshouse in the View Garden, the knowledge that the Miles Family took great pride in growing exotic plants, and the notion that the View Garden was set out as an Italianate garden, all suggest that these blocks could have formed seasonal platforms for the display of tender potted plants or citrus trees.
