INVESTIGATIONS IN THE VIEW GARDEN

Volunteer archaeology work in the
Kings Weston walled gardens

13th Jan 2024

Kings
Weston
Action
Group

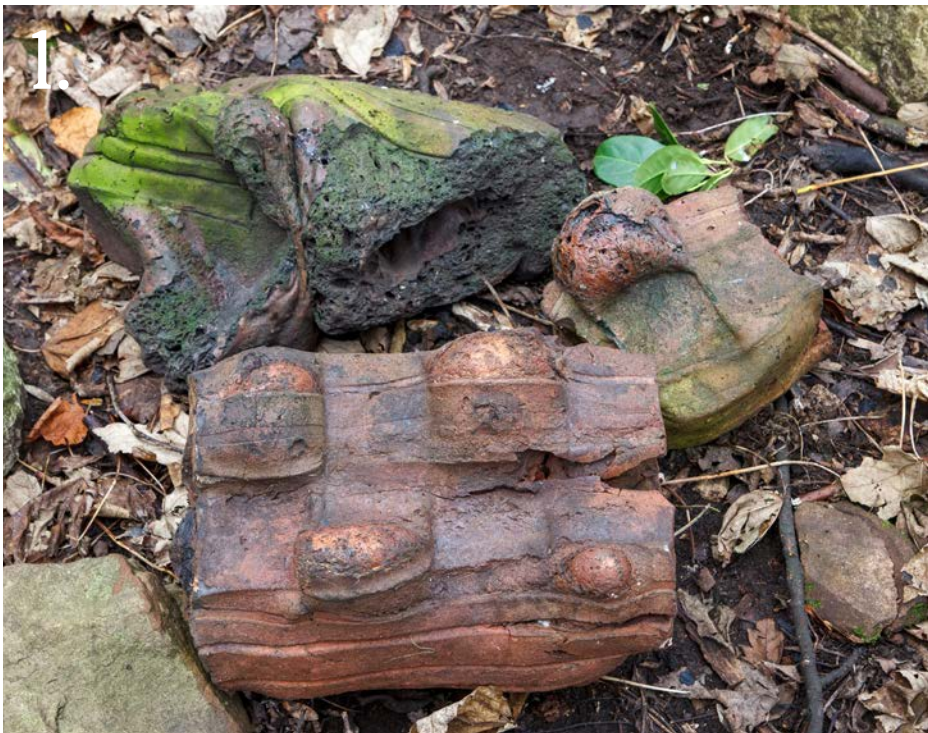
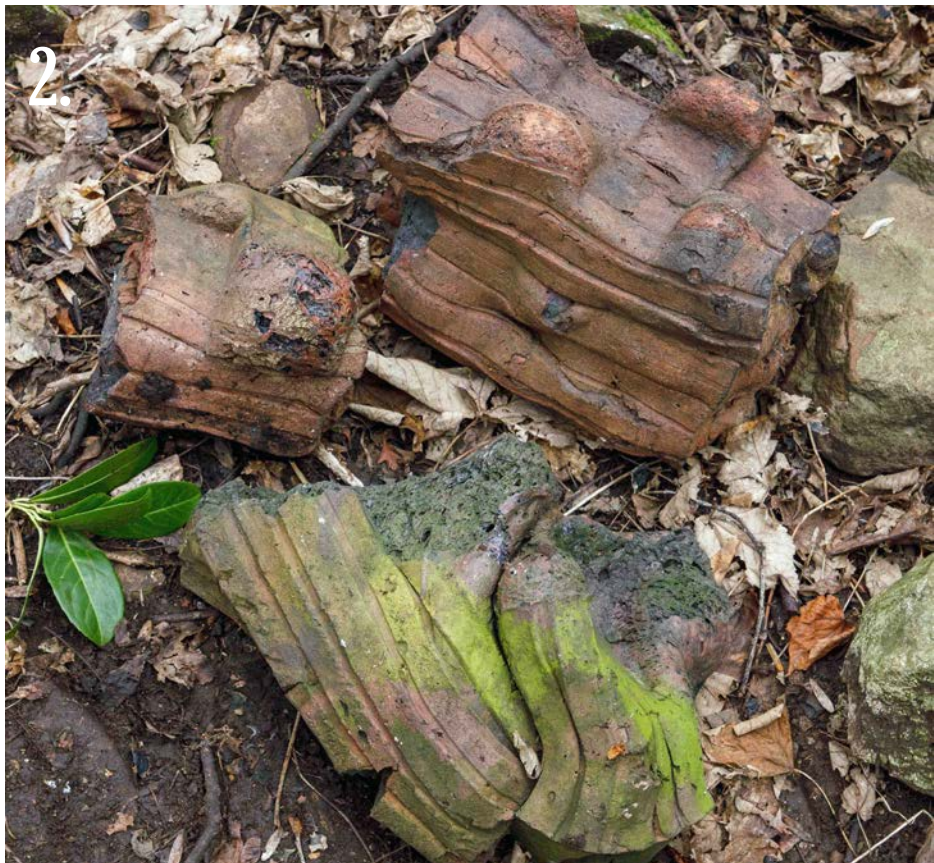
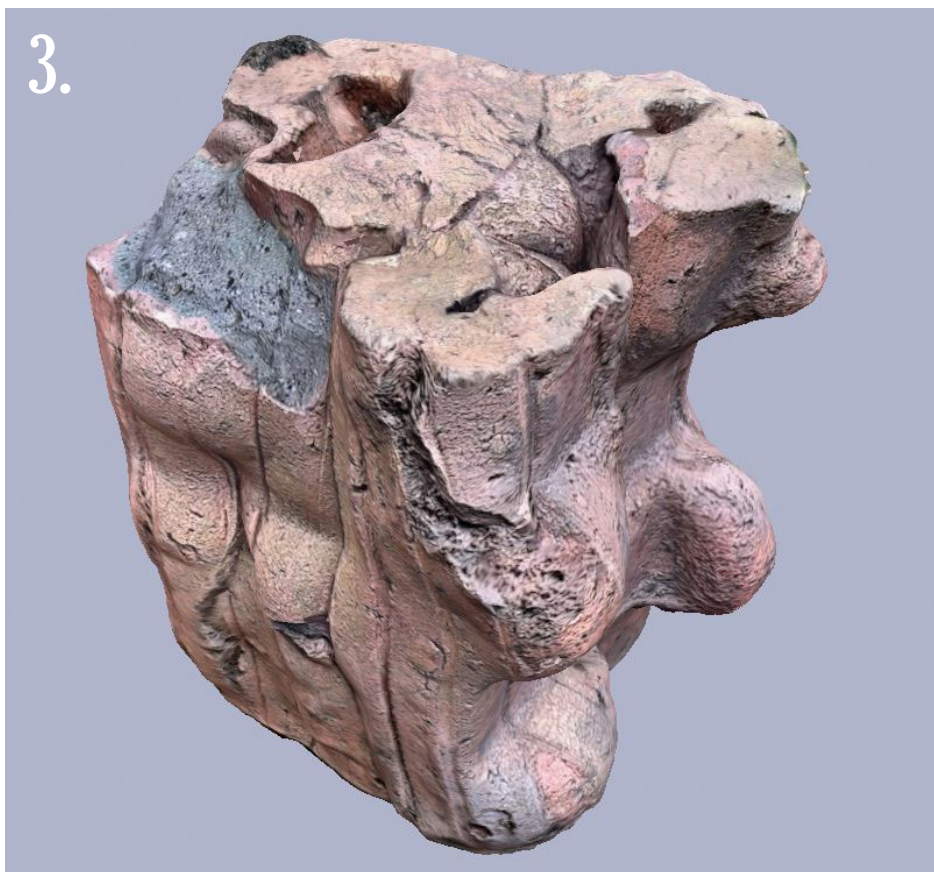
Several sections of a feature have been recovered from the north-western side of the site (1&2), in areas outside the centre of the garden area. The material is peculiar, having the character of brick clay to the outside, but with a core of clay or a bubbled vitreous material internally. The exterior faces of the three fragments so far recovered exhibit an inferentially wrought design, with bulbous features and striations scratched in a rough grain down surfaces. The blocks are all very irregular in form, some clearly broken fragments, but the largest of them (3), measuring about 11 ¾ inches in height, appears to have a finished top and bottom surface. It appears to be part of a segmental structure built up from various elements.

The elements so far found appear to be fragments of a rustic tree-type structure, with the clay intend to replicate gnarled and twisting wood. It's difficult to find parallels for this sort of feature in other historic gardens, though smaller pottery tree trunks, often referred to as strawberry planters, were frequently used for the showcasing of ferns or other plants. The fragments would suggest

a much larger feature of similar rustic character that may have stood in the View garden. The Georgian glasshouse might have been the most likely location for this built structure in the View Garden, though an outside location, possibly one elsewhere in the walled gardens or park, can't be discounted. The fragmentary condition and scattered location of the finds suggest it was deliberately damaged and discarded, whether systematically or through decay and vandalism.
